Retrofitting of Infilled Frame in Reinforced Concrete Structure

Wajid Ali¹, Syed Azmat Ali Shah², Khan Shahzada^{1b}, Syed Mohammad Ali^{1c},
Sajjad Wali Khan^{1d}

ABSTRACT

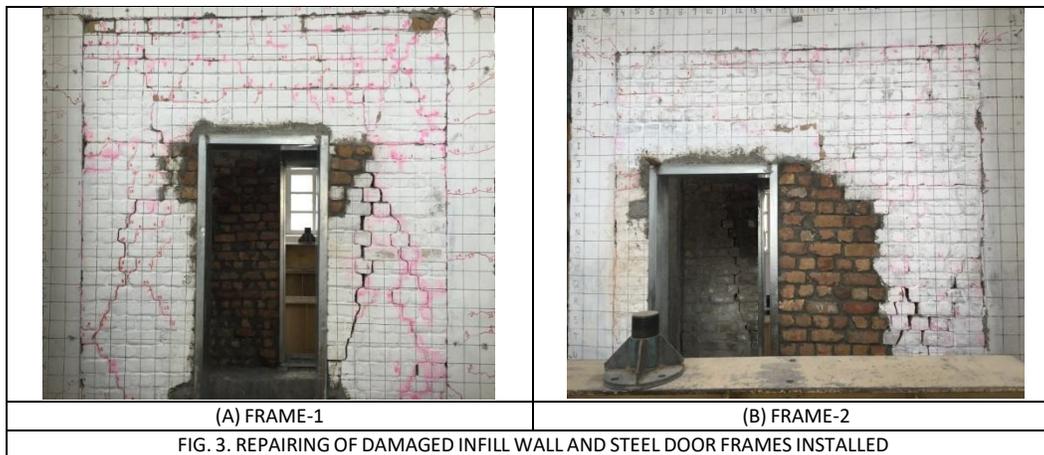
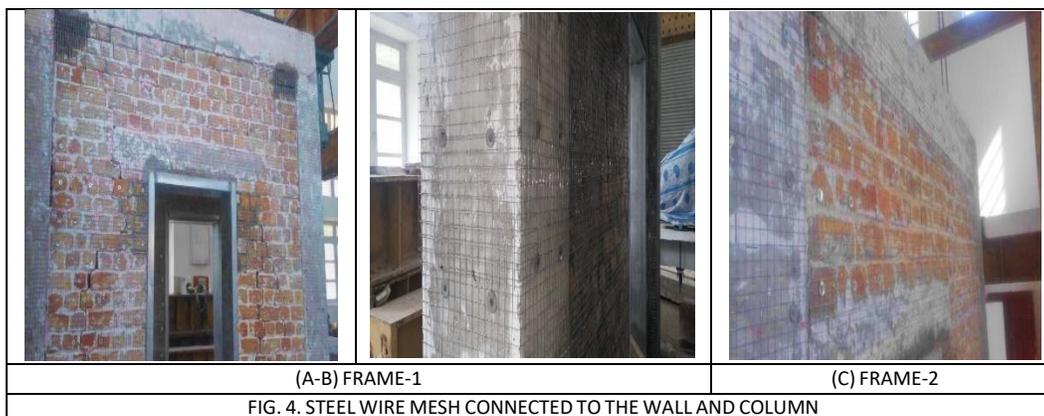
Manzouri *et. al.* [18] endorsed that cracks having thickness greater than 19mm; the damaged areas can be reconstructed. On the recommendation of above researcher, those areas of the infill wall which were damaged during testing before retrofitting and were having cracks greater than 19mm were dismantled. After dismantling, to make the model more realistic, steel door frames of gauge 18 were installed at the door openings which were not present in original models. Removed part of the infill was reconstructed with new masonry unit (bricks) using mortar of 1:4. The ratio of mortar used was same as that of original specimens before retrofitting. Installation of steel door frames and reconstructed portions of the infill walls are shown in Fig.3(a-b).

Ferrocement overlay was used for the retrofitting of the damaged frames. According to the guidelines for application of reinforced plaster [14] the gauge and spacing of wires in a mesh should be such that to provide a minimum reinforcement ratio of 0.05% of the gross area of masonry. A corrosion resistant welded steel wire mesh of gauge 18 (diameter = 1.18mm) with a spacing between two alternative wires of 19.05mm having reinforcement ratio of 0.05% was used which was compliance with the guidelines for application of reinforced plaster. Steel wire mesh was connected to the whole infilled frame including beam, columns and both sides of the infill wall, utilizing screw No.10 and steel washers of external diameter 25.4mm. Length of the screws used was 38.1mm. Steel wire mesh was overlapped through a length of 152.4mm. Steel wire mesh connected to the infill wall and columns is shown in Fig. 4(a-c).

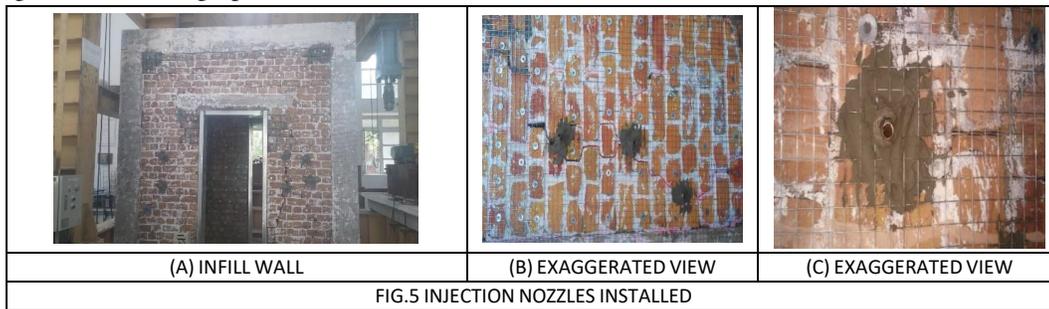
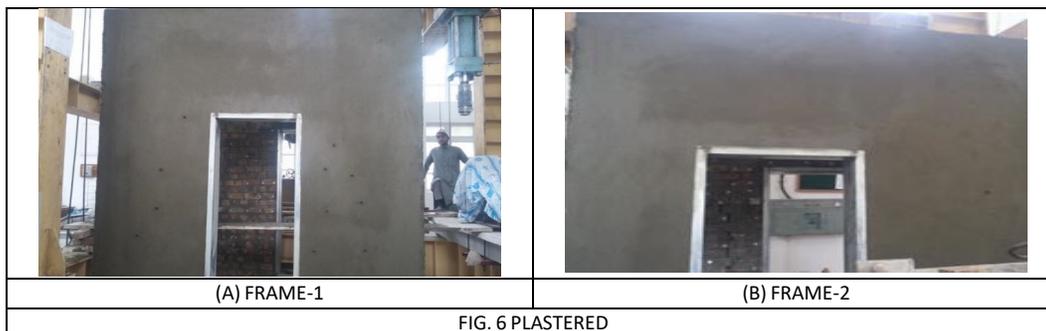
Miha [16] suggested that grout injection can only be used for cracks having a width ranging from 2-10mm while Schuller *et. al.* [17] recommended that grout injection is effective for cracks having a thickness ranging from 0.08-12 mm. As recommended by [6 -7] cracks with width less than 10 to 12mm were repaired according to the guidelines for application of grout injection [14]. Holes were drilled in mortar joints along the crack length and injection nozzles of length 101.6mm and diameter of 9.525mm were fixed at the drilled holes using fast binding cement paste (1:2). The distance between injection nozzles was 304.8mm. Injection ports were fixed after connecting wire mesh to the wall surface. Injection nozzles installed along the crack length in the infill wall are shown in Fig. 5(a-c).

best option is to inject grout after plastering the whole surface area. Plastered Infilled Frame-1 and Frame-2 are shown in Fig. 6(a-b).

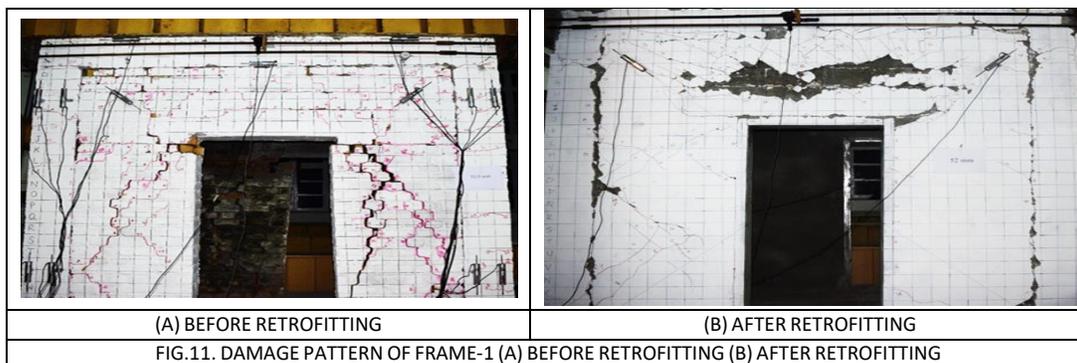
FIG.11. DAMAGE PATTERN OF FRAME-1 (A) BEFORE RETROFITTING (B) AFTER RETROFITTING

The final crack pattern of the Frame-1 before and after retrofitting is shown in Fig. 11. Before retrofitting; in each masonry piers diagonal cracks were originated

from the corners of door opening and moved diagonally towards the end of the wall. Beside this sliding shear and corner compression was also noticed as shown in Fig. 11(a). The application of ferrocement overlay prohibited these diagonal cracks in piers and a more stable crack pattern was observed as shown in Fig. 11(b). A series of small diagonal cracks were seen at the spandrel.

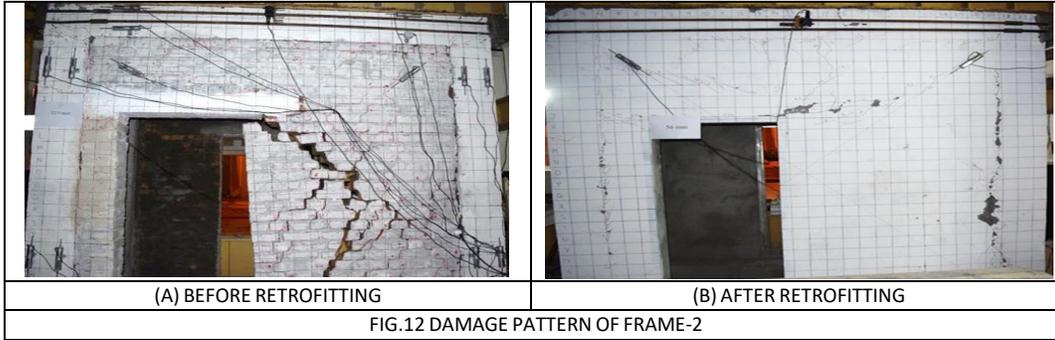
The final crack pattern of the Frame-2 before and after retrofitting is shown in Fig. 12. Diagonal shear crack on the right side of the door opening was prevailing before retrofitting as shown in Fig. 12(a). After installing steel door Frame and application of ferrocement overlay no diagonal shear crack appeared; instead a diagonal shear cracks at the right corner of the door was observed and propagated towards the beam-column joint as shown in Fig. 12(b).
