Application of Infrared Thermography in Power Distribution System

ANWAR ALI SAHITO*, IRFAN AHMED HALEPOTO**, AND SHAH MURAD TUNIO***

Key Words: Distribution System Maintenance, Hyderabad Electric Supply Company, Infrared Thermography, Transformer Damage.

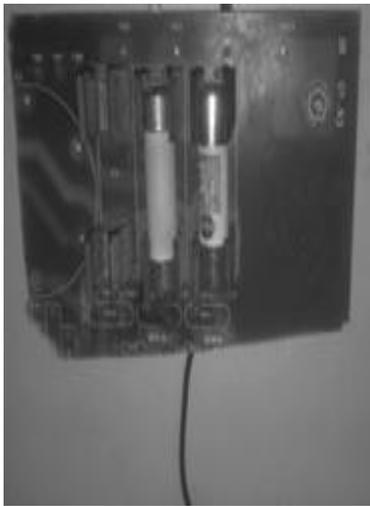
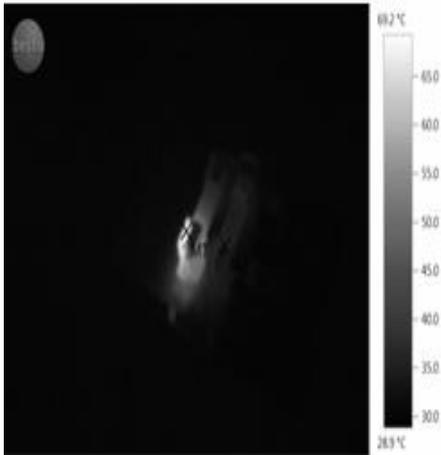
To detect the power loss due to loose contacts using thermography, a laboratory experiment is conducted with two fuses. One fuse was made with a loose contact and other properly connected. 1kW load was supplied through both fuses. Fig. 1(a-b) show experiment arrangement and its thermal image respectively. Observed results are given in Table 2. It is clear that with loose connection the recorded power loss is of 8W as compared to 6.4W for tight connection. 1.6W increase in power losses is observed when connected load is only 1kW. Voltage drop also increases by 0.4V for loose contact. Increased power loss is identified by an increase in temperature from 35.1°C (marked X_{M2}) to 39.2°C (marked X_{M1}) (by the margin of 4.1°C) by thermographic camera. Relative temperature measurement is difficult without thermographic camera. It is, therefore, concluded that for this case thermography detects power loss caused by loose contacts.

FIG. 1. FUSES ARRANGEMENT AND CAPTURED THERMAL IMAGE FOR LABORATORY EXPERIMENT-1

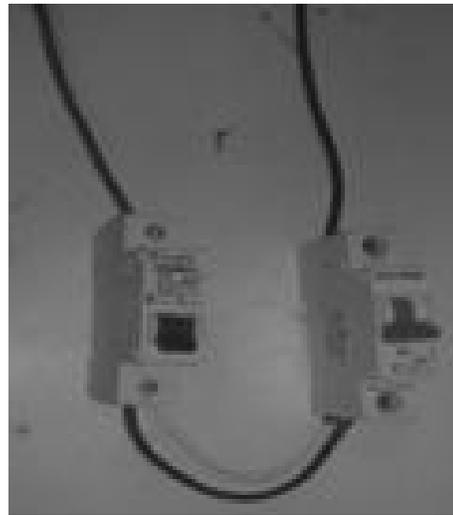
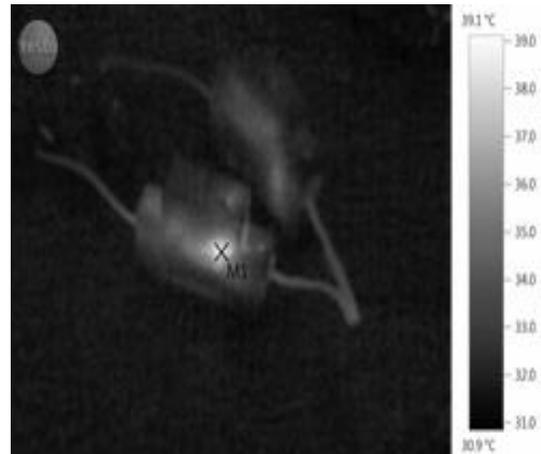
In second experiment two CB (Circuit Breakers) are used in series to supply a load of 2kW. One circuit breaker is tightly connected whereas other has a loose connection as shown in Fig. 2(a-b). Observed results are given in Table 3. It can be observed that a loose connection with CB 2 increases power loss by 6.4W (16W compared to 9.6W) for connected load of 2kW. Also there is a voltage drop 0.4V for loose contact. Corresponding change in temperature indicated by thermal image is from 34-39.1°C (difference of 5.1°C). Hence it is clear that temperature rise shown by thermographs represent power loss caused by loose connections.

FIG. 2. CIRCUIT BREAKERS ARRANGEMENT AND CAPTURED THERMAL IMAGE FOR LABORATORY EXPERIMENT-2

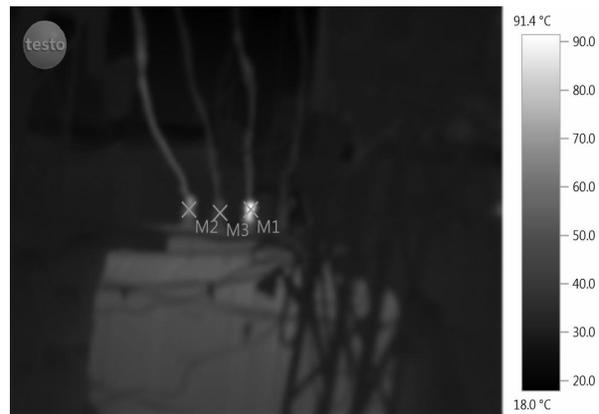
Distribution transformers from 10-1500kVA are used in distribution system of HESCO. Transformer damage is common problem in HESCO resulting in loss of money and long outages for consumers. Overloading, load unbalancing and improper protection are major causes of transformer damage. IR thermography is simple, reliable and safe method to detect overloading and unbalanced loading. Thermographs can be taken from ground at different time intervals to check for any problem. Fig. 3 shows thermograph of a distribution transformer located at Qasimabad city, Hyderabad having unbalanced loading. One bushing is at a higher temperature indicating more load on that phase. It is then confirmed from the current measured at outgoing leads from LV bushings. Currents measured for three phases of 200kVA transformer are 273, 208 and 394 Amperes. Thermograph shows temperatures of 59.4, 42.4 and 91°C respectively for three phases. It is quite obvious from the results that unbalanced loading can be detected easily by thermographs.

FIG. 3. THERMOGRAPH SHOWING LOAD UNBALANCE ON 200KVA TRANSFORMER LOCATED AT QASIMABAD CITY, HYDERABAD

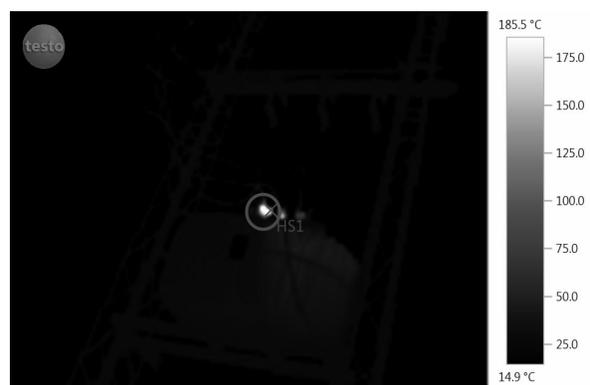
Transformers are observed to have loose connections at bushings causing increased power loss. Loose connections convert in open circuits resulting in power outages and unbalanced operation of the transformer. Fig. 4 shows 200kVA transformer installed at MUET (Mehran University of Engineering & Technology), Jamshoro, Pakistan having loose connection at one high voltage bushing. Temperature of hot spot is 185°C

FIG. 4. THERMOGRAPH SHOWING LOOSE CONNECTION ON HIGH VOLTAGE BUSHING OF 200KVA TRANSFORMER INSTALLED AT MUET, JAMSHORO

compared to other bushing where temperature is 84°C. This loose connection identified by hot spot in thermograph can be repaired to avoid any disturbance and discontinuity in supply.

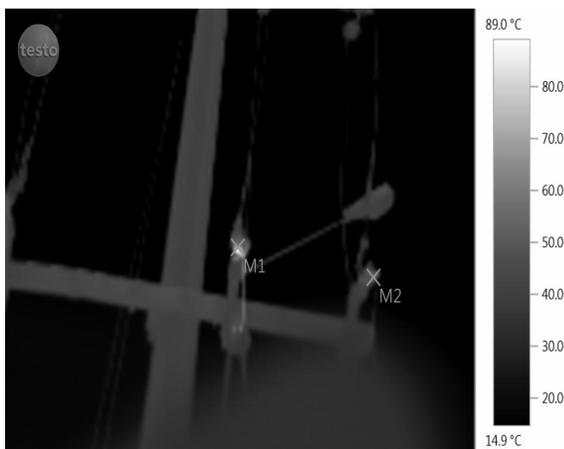
Drop out fuses are used on high voltage side of the transformer to provide protection for the faults in transformer and its secondary network. Proper sized fuses are required but rarely used. Mostly single strand of a conductor is used as fuse. These dropout fuses are connected between high voltage line and bushings with ACSR (Aluminum Conductor Steel Reinforced) conductors. Drop out fuse assemblies also contain loose connections. Fig. 5 shows thermograph of drop out fuses for 100kVA transformer installed at MUET, Jamshoro. It shows hot spot on one phase indicating a

lose connection. Temperature of the hot spot is 93°C whereas reference temperature is 51°C . This identified lose connection can be forwarded to maintenance staff to avoid any unplanned outage. Line conductors/cables and service wires also contain lose connections, joints and unbalanced current flows, detectable through IR Thermography.

FIG. 5. THERMOGRAPH SHOWING LOSE CONNECTION AT DROP OUT FUSE ASSEMBLY OF 200KVA TRANSFORMER AT MUET, JAMSHORO

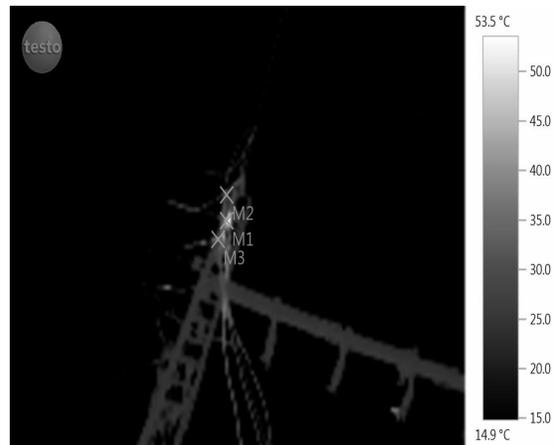
Fig. 6 shows thermograph indicating improper service line connections observed at residential society of MUET Jamshoro. Temperature of 53.5° is observed at hottest spot as compared to 29.5° for service lines. Identified service line connections are recommended for remedial actions using proper line taps. Fuses are installed with supply systems of various equipment in power system.

FIG. 6. THERMOGRAPH SHOWING LOSE CONNECTION AT SERVICE LINE CONNECTIONS AT MUET RESIDENTIAL SOCIETY, JAMSHORO

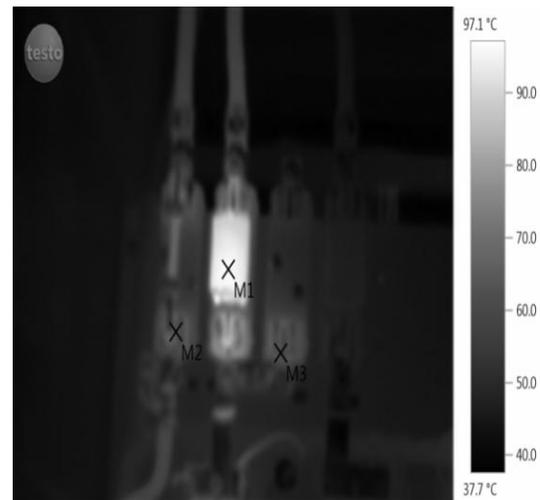
Fig. 7 shows thermograph of fuses installed at telephone exchange Hyderabad. Temperature of middle fuse is observed 95°C whereas other fuses are at 64°C . This variation in temperature indicates unbalanced loading on the system. Supply system for heavy industrial loads, panel boards, capacitor banks, circuit breakers and bus-bars are also checked through thermographic cameras. Thermographs show unbalanced loading, lose connections and improper joints. Identified problems are analyzed to set priority for maintenance work.

FIG. 7. THERMOGRAPH SHOWING UNBALANCED LOADING AT FUSES AT TELEPHONE EXCHANGE HYDERABAD
