# An Experimental Study on the Deterioration of Paint Coatings in the Bilges of a Sea Vessel

TANZILA YOUNAS\*, AQUEEL SHAH\*, AND TAHIR ABDUL HUSSAIN RATLAMWALA\*\*

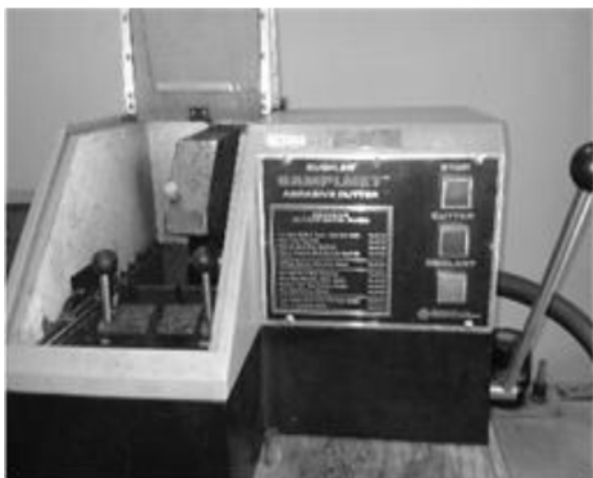
FIG. 2. ABRASIVE CUTTER

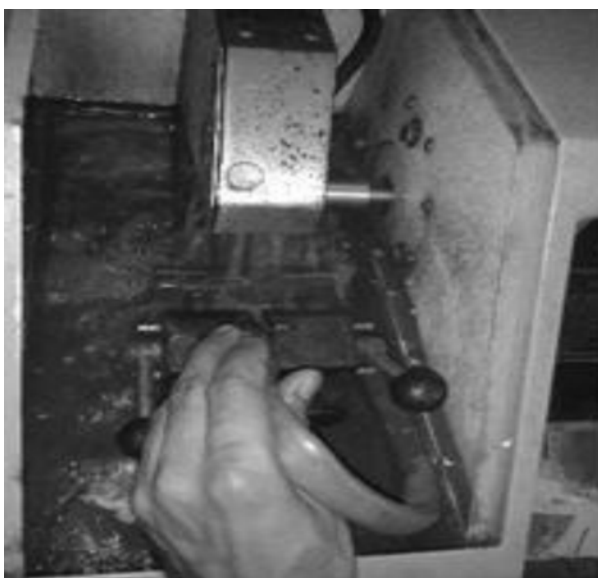
FIG. 3. CUTTING OF PLATE WITH ABRASIVE CUTTER

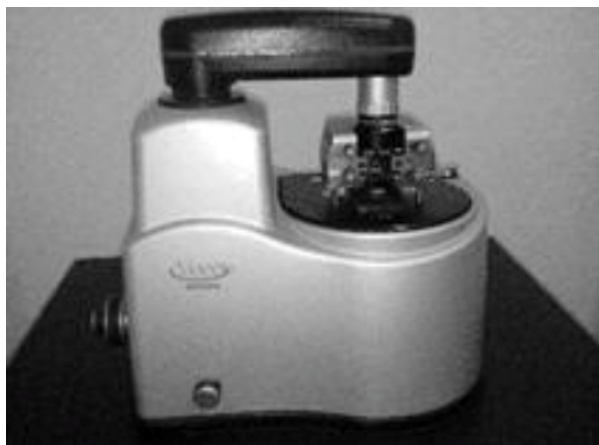
FIG. 4. ATOMIC FORCE MICROSCOPE (AFM)

These samples were then washed with fresh water and detergent. However black protective film formation was observed on 2nd and 3rd coatings after 30 days. This film had been removed with the help of engine oil in order to observe the underlying formation of film pit. Images were taken under optical and atomic force microscope. Images were then analyzed for the number of pits and the size of pits with respect to time. Characteristics of these tested organic coatings have been analyzed by the help of AFM and optical microscopes as shown in Figs. 4-7.

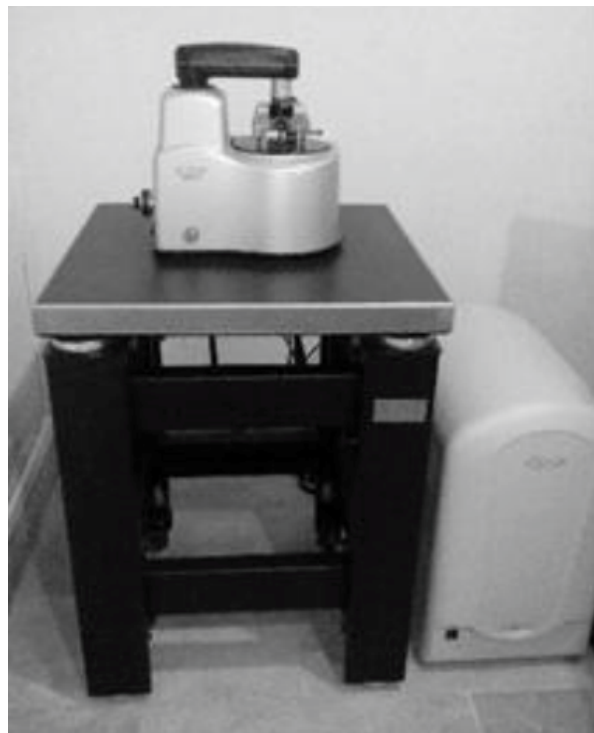
FIG. 5. PLACEMENT OF SAMPLE UNDER AFM MICROSCOPE

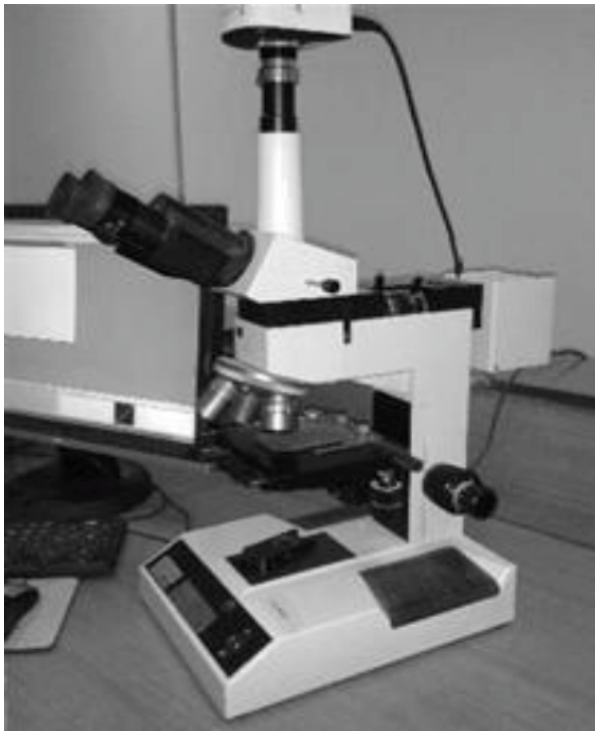
FIG. 7. PLACEMENT OF SAMPLE UNDER OPTICAL MICROSCOPE

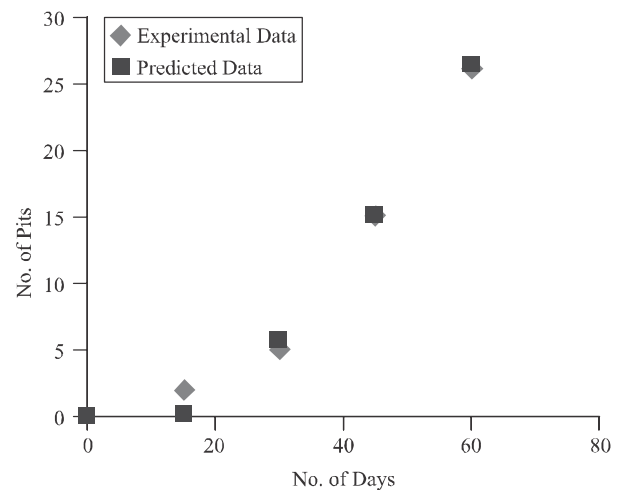
FIG. 10. COMPARISON BETWEEN EXPERIMENTAL DATA AND PREDICTED DATA ACCORDING TO EQUATIONS FOR SEALER COAT

Our main focus of study was to investigate the deterioration of protective coatings in bilges water. Corrosion behavior of mild steel coated with three different coatings which are primer, sealer and under coat immersed in bilges water at 25°C was measured. The tested results are shown in Figs. 9-11.

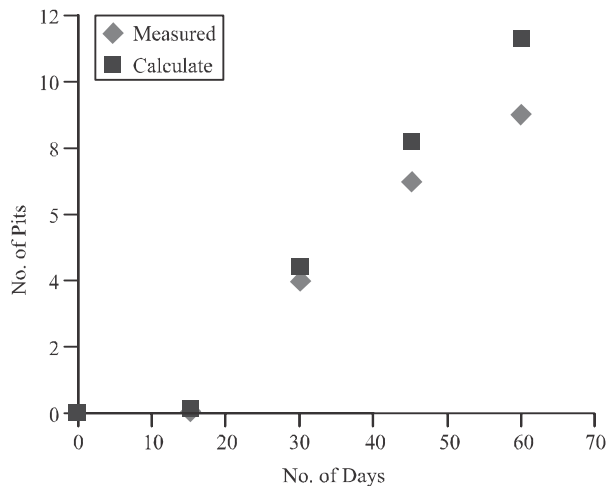
FIG. 11. COMPARISON BETWEEN EXPERIMENTAL DATA AND PREDICTED DATA ACCORDING TO EQUATIONS FOR SEALER COAT

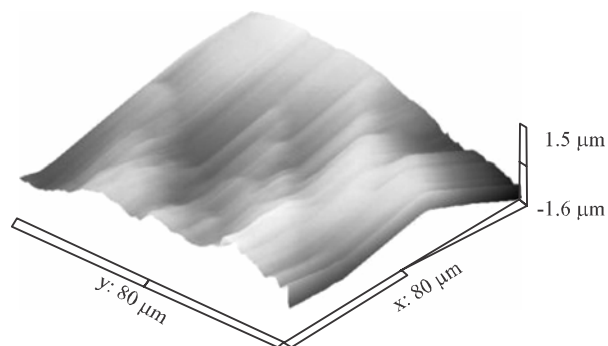
FIG. 16. AFM TOPOGRAPHY OF PRIMER COAT

AFM has been adapted to analyze the detailed surface topography of the bilges paint and metal-coating interface. AFM is considered a very important tool in understanding the behavior of protective coatings [30]. AFM was used to inspect the surface morphology of different surface coatings. Figs. 15-17 shows us the AFM captured images of these coatings. The surface permeability and roughness

is shown in the captured images. It can be seen from the images obtained, at the view of the height, the surface morphology of coatings differs from each other. The porous nature of primer coating shows that the degradation of the coating occurs at the exposed reactive points at first. While other epoxy pigmented coatings show comparatively less surface roughness and blister formation. Therefore, they are better anti-corrosive coats which exhibit good non-permeable characteristics towards liquid diffusion, despite the fact that AFM tip can't locate nanoscopic pathways [31] that might exist in these films.
